PERATION

GREENHOUSE

SCIENTIFIC DIRECTOR'S REPORT

ANNEX 3.2 U. S. NAVY STRUCTURES

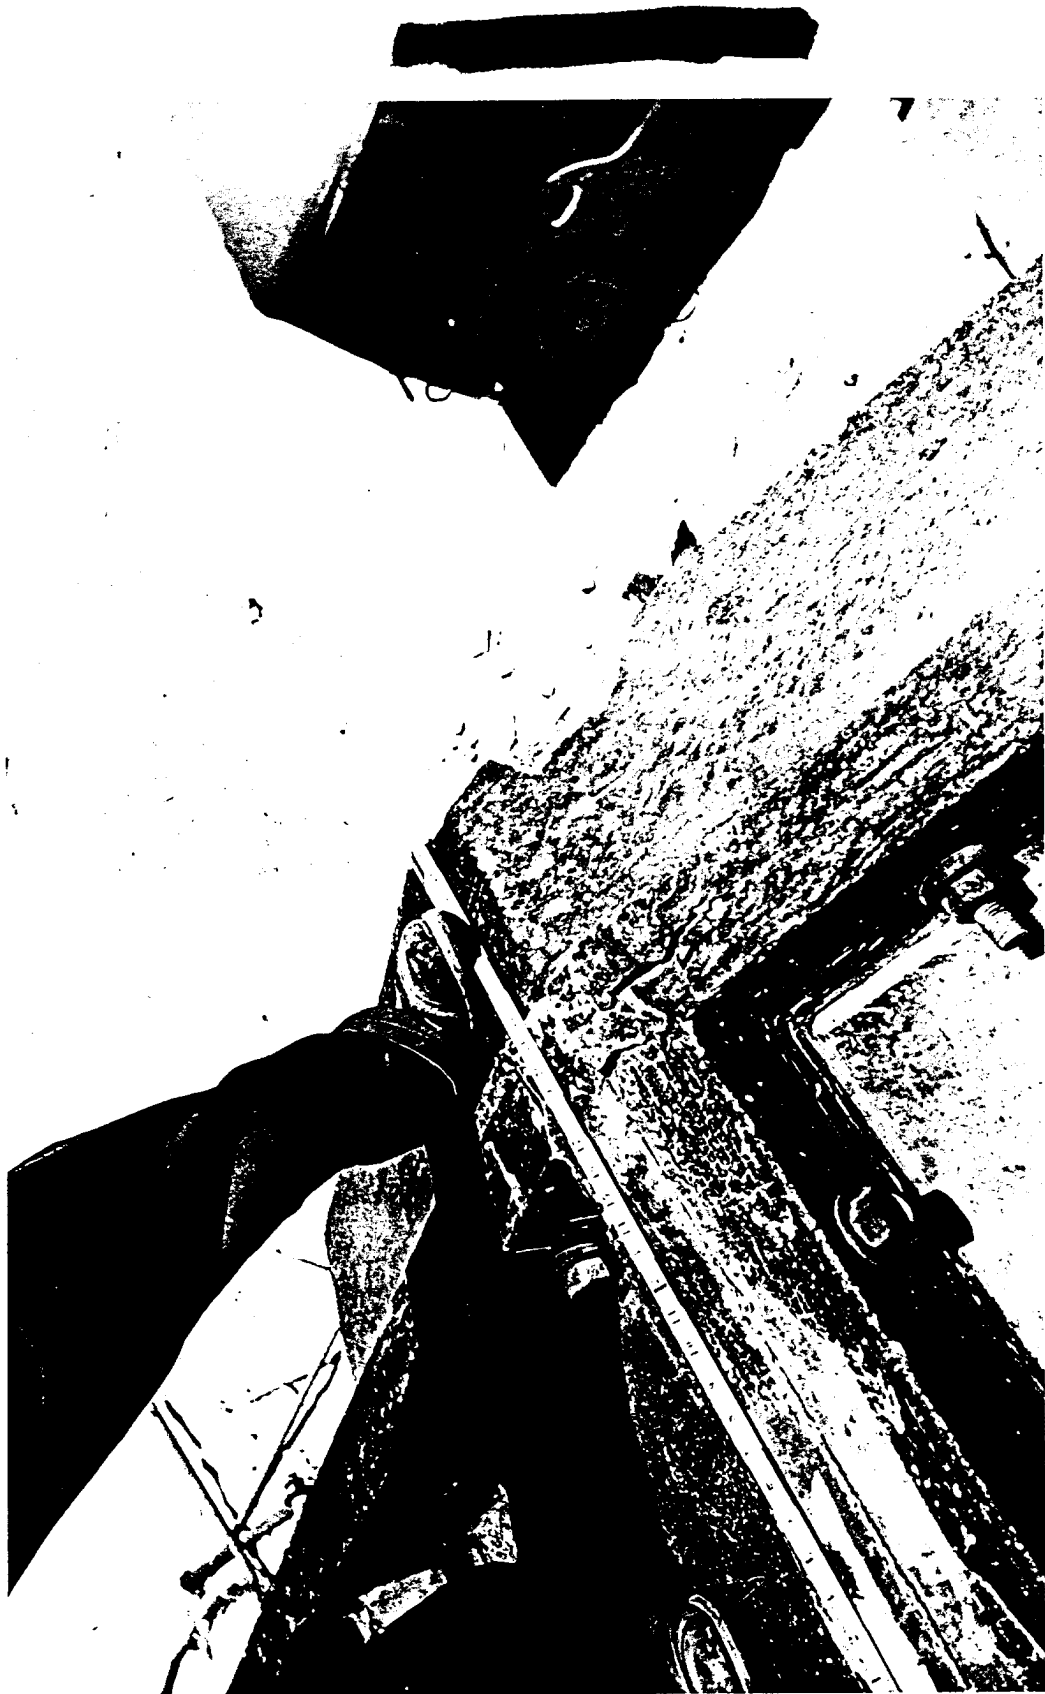
Fig. L. 379 Detail View of Joint of Ribs-out Panels Adjacent to Right End of Structure, 3.2.4b

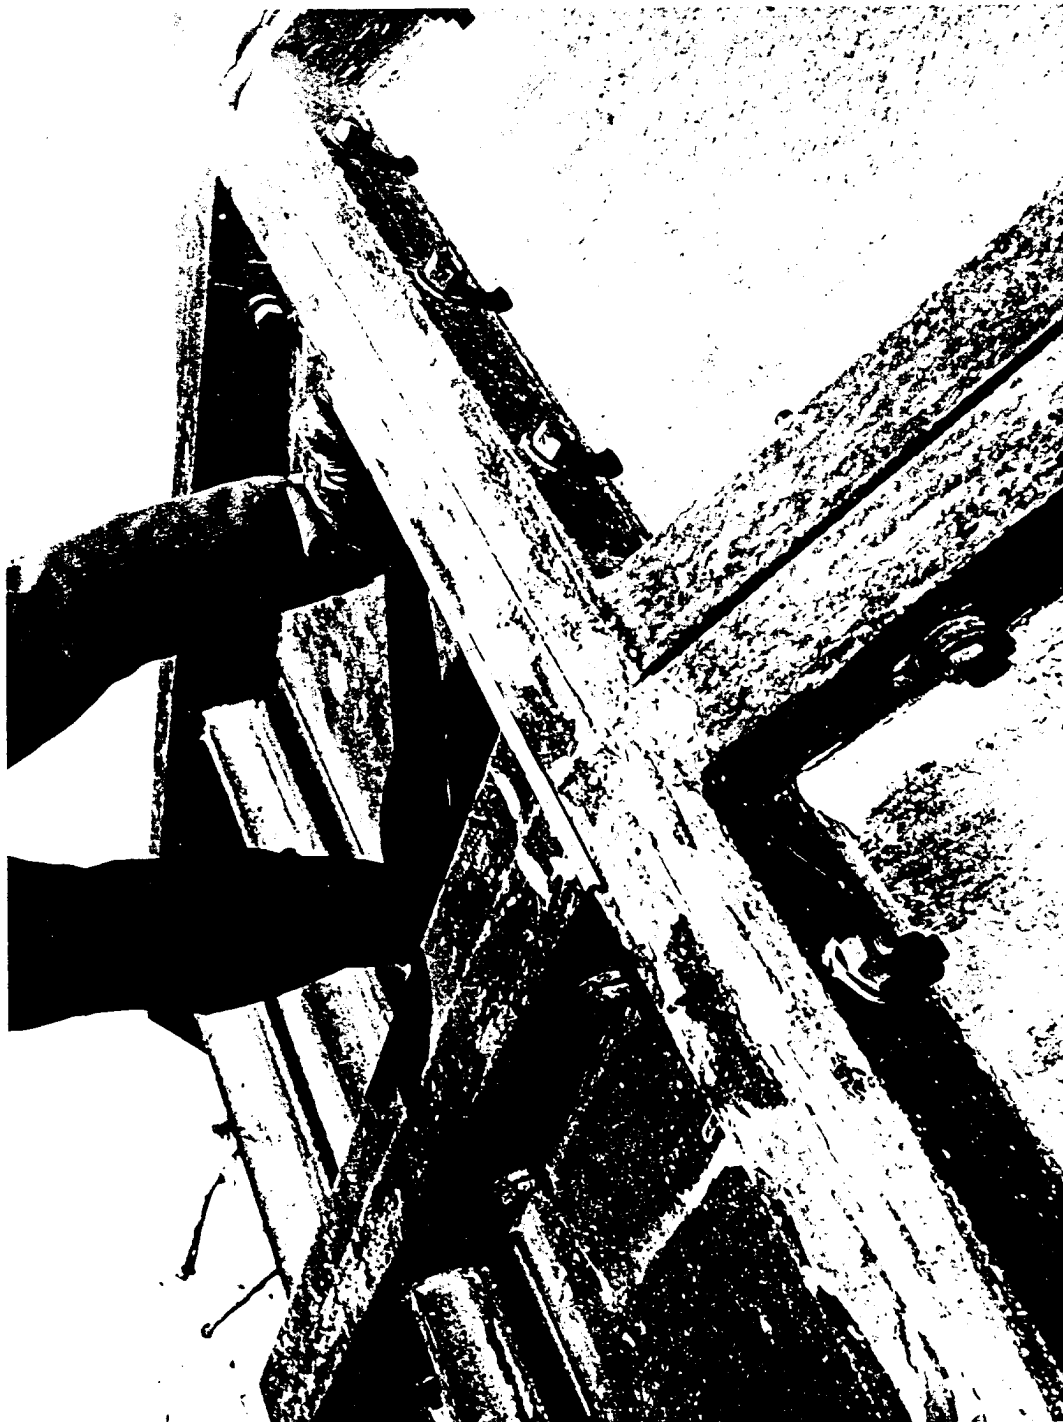
Fig. L. 380 Detail View of Joint of Ribs-out Panels First and Second from Right End of Structure, 3.2.4b

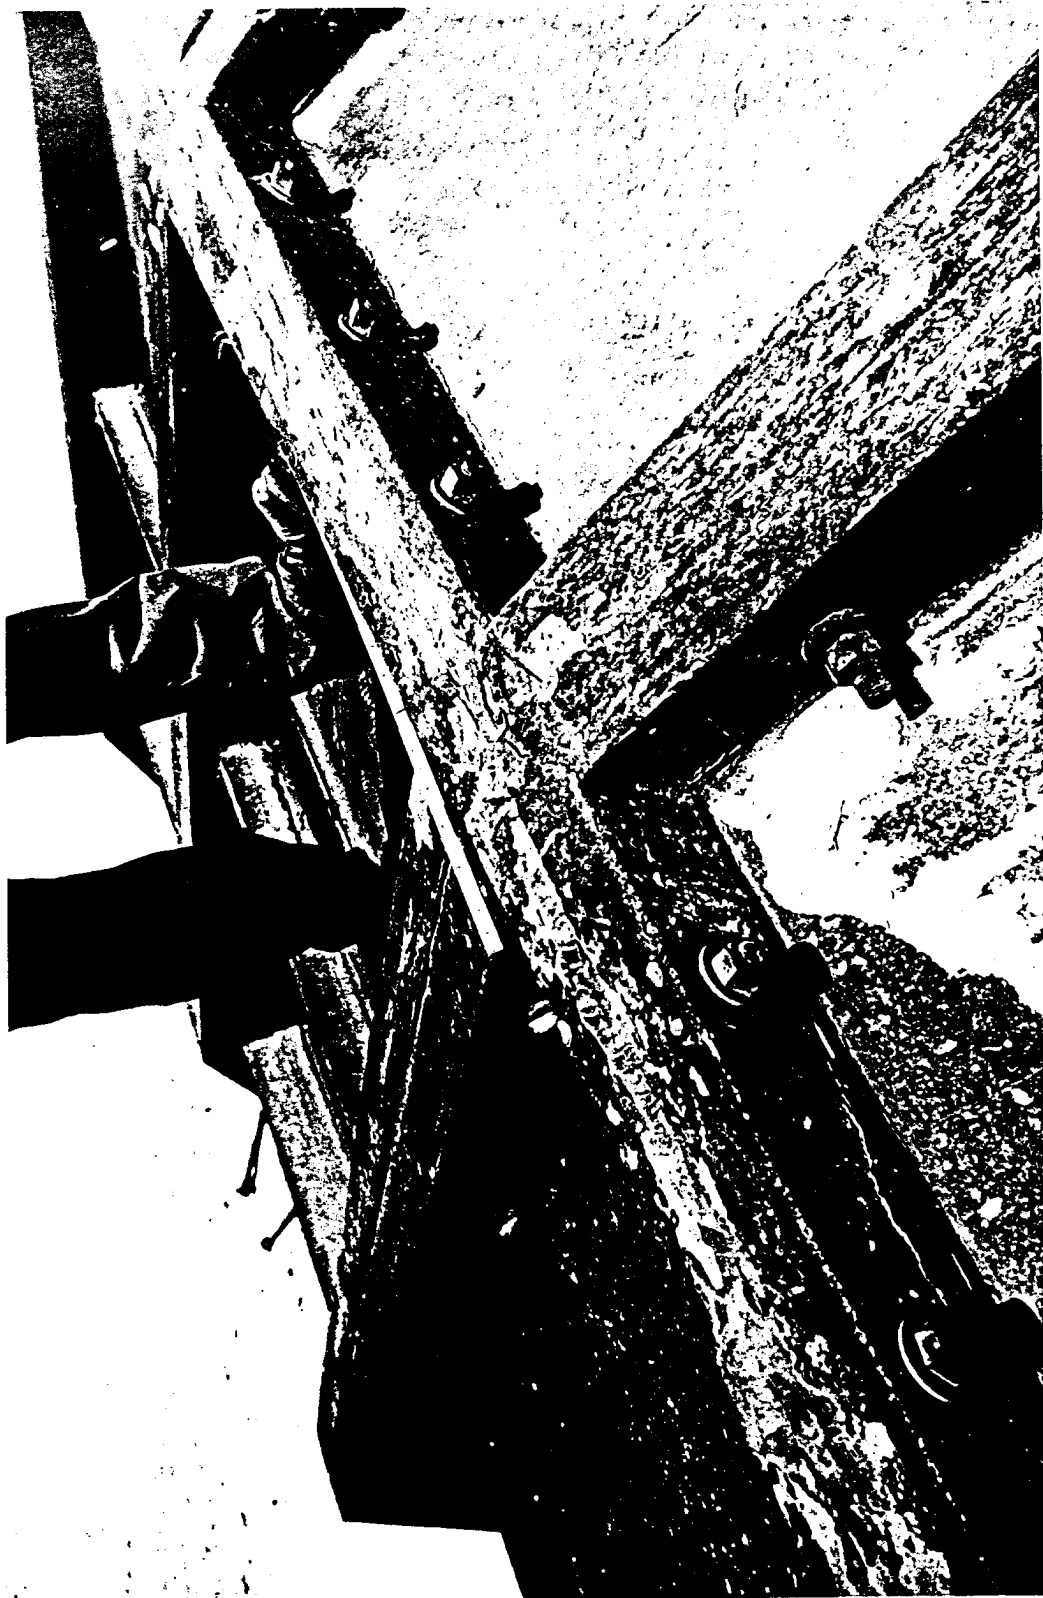
Fig. L. 381 Detail View of Joint of Ribs-out Panels Second and Third from Right End of Structure, 3.2.4b

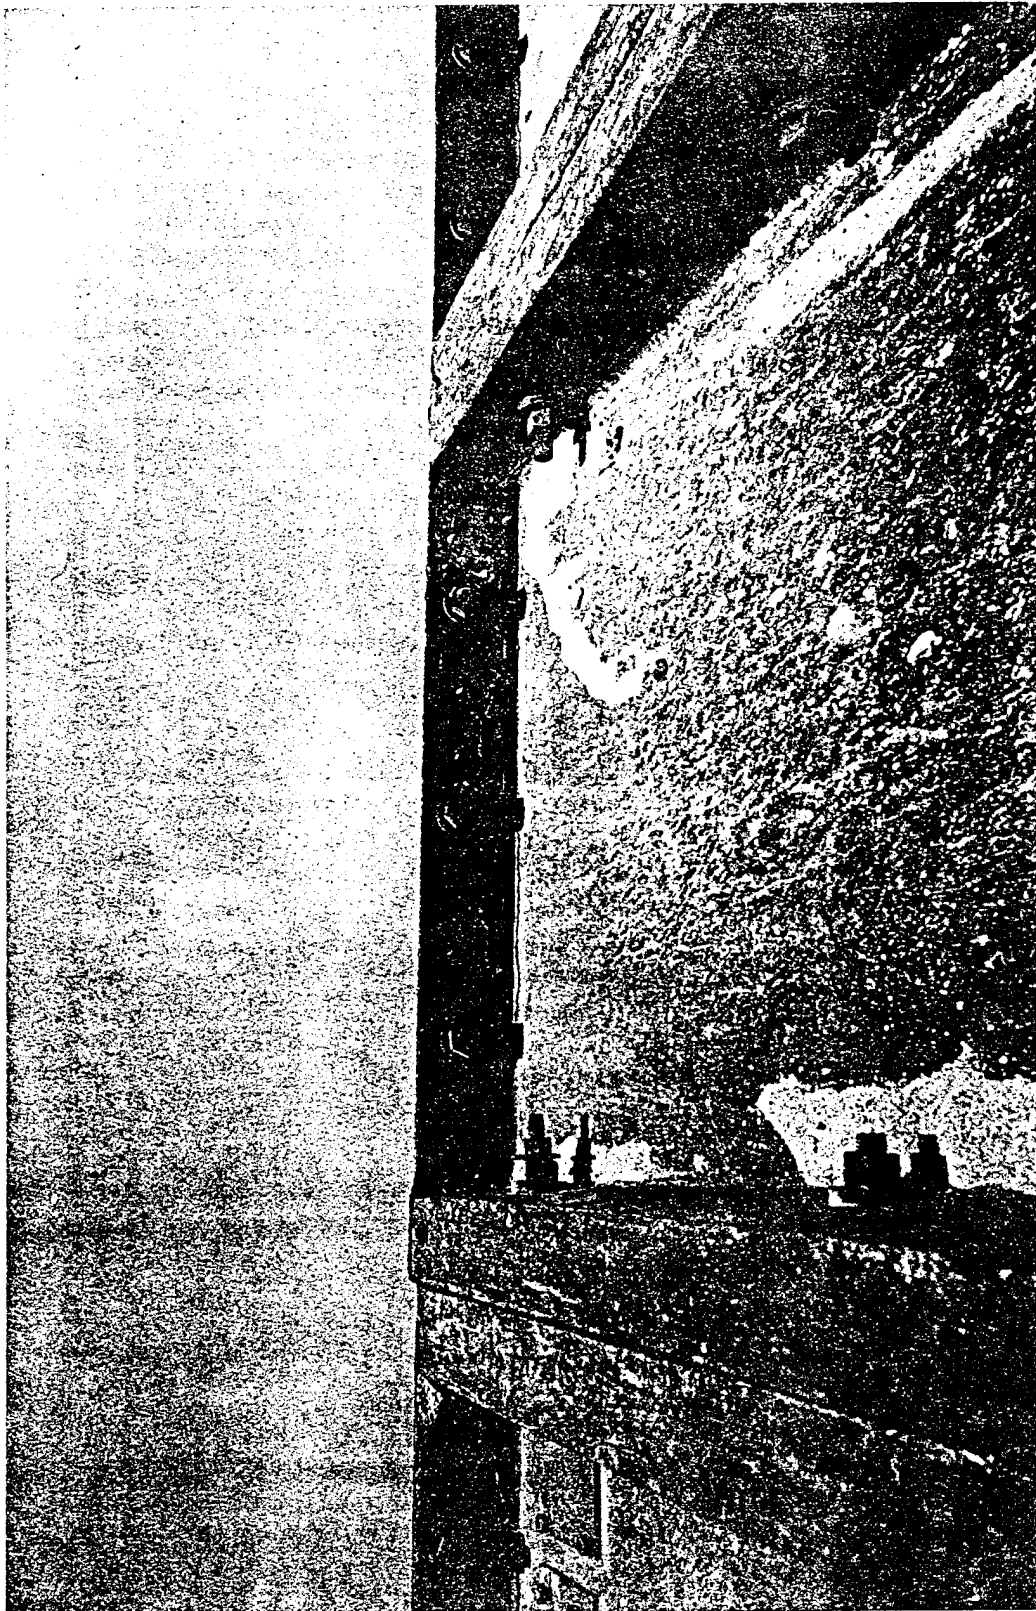
Fig. L. 382 Roof Section Toward Crown of Ribs-out Panel Third from Right End of Structure, 3.2.4b

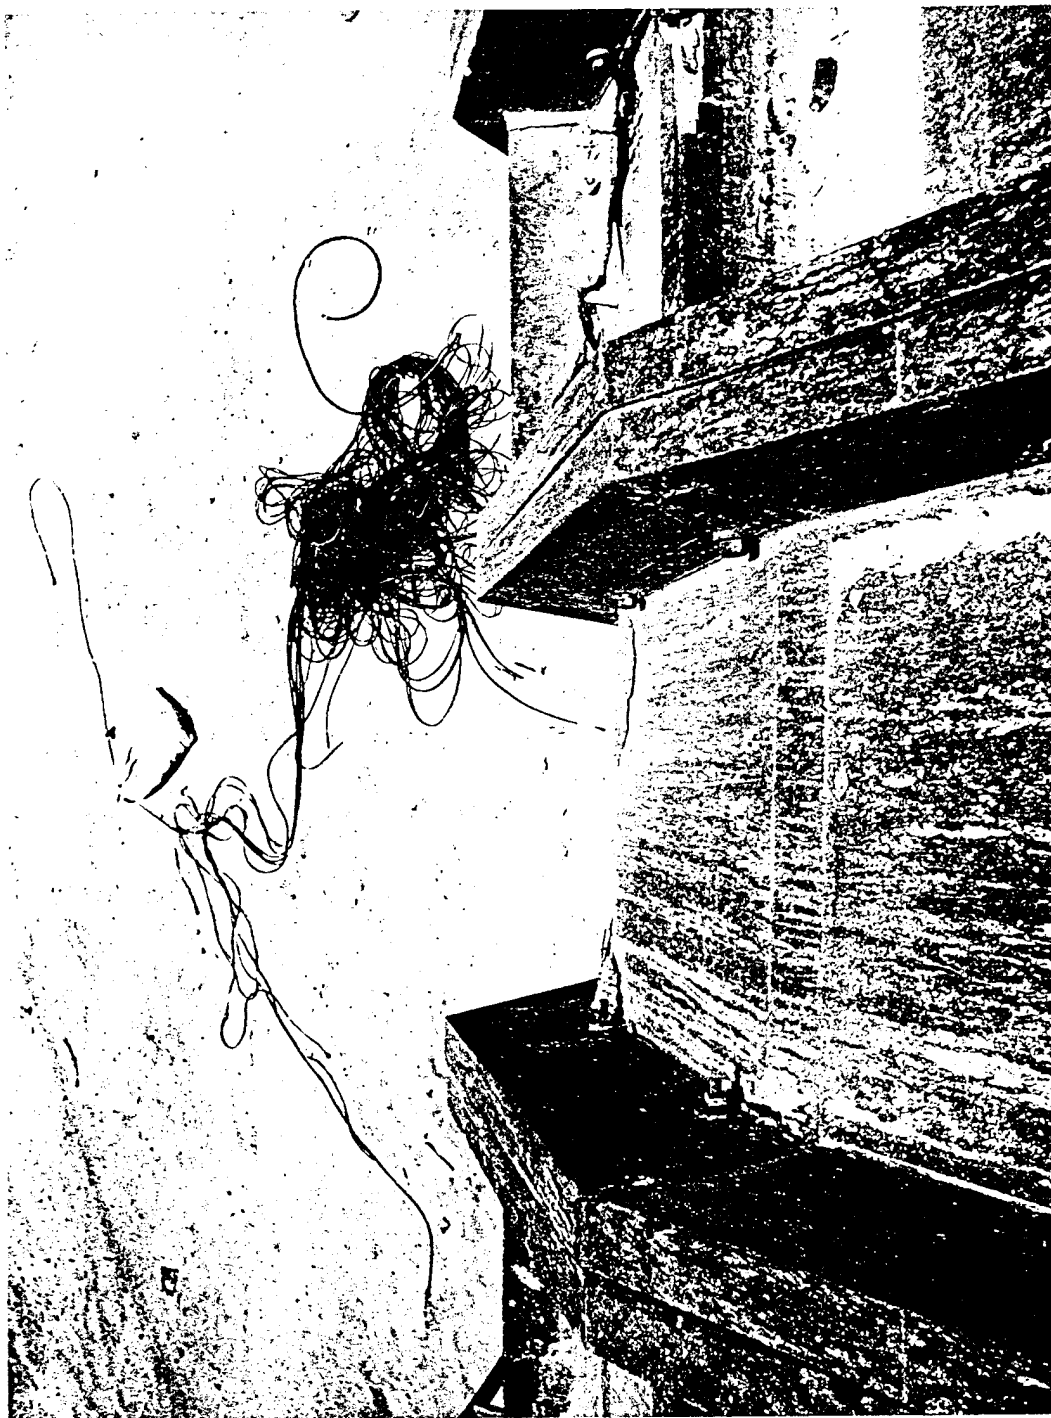
Fig. L. 383 Roof Section Toward Base of Ribs-out Panel Third from Right End of Structure, 3.2.4b

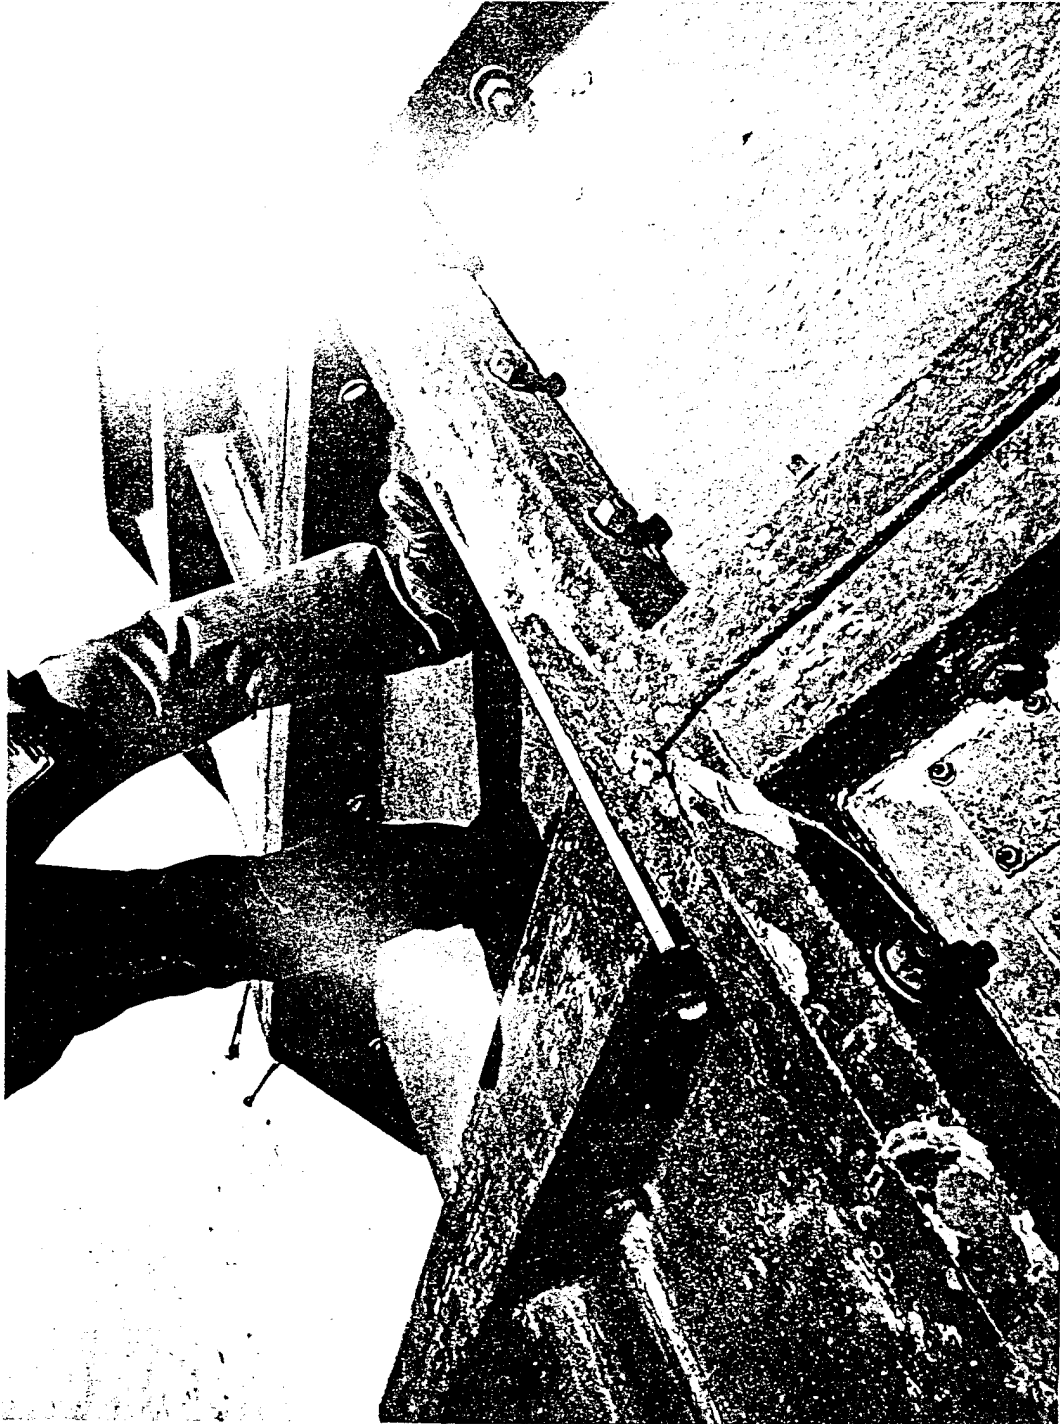
Fig. L. 384 Detail View of Joint of Ribs-out Panels Third and Fourth from Right End of Structure, 3.2.4b

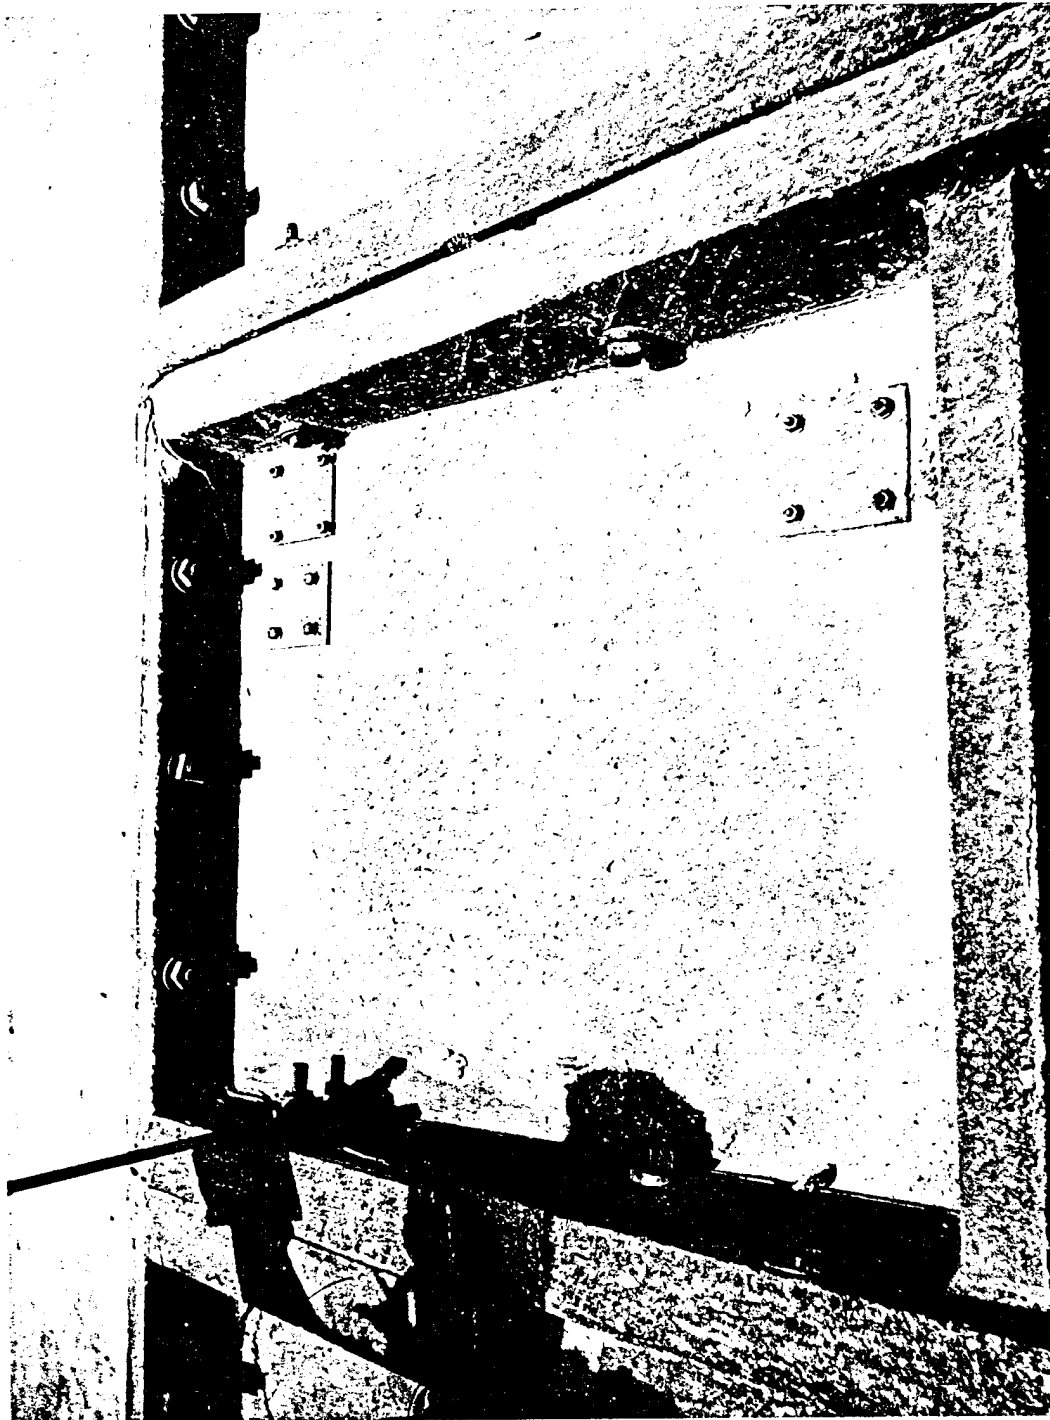
Fig. L. 385 Roof Section Toward Crown of Ribs-out Panel Fourth from Right End of Structure, 3.2.4b

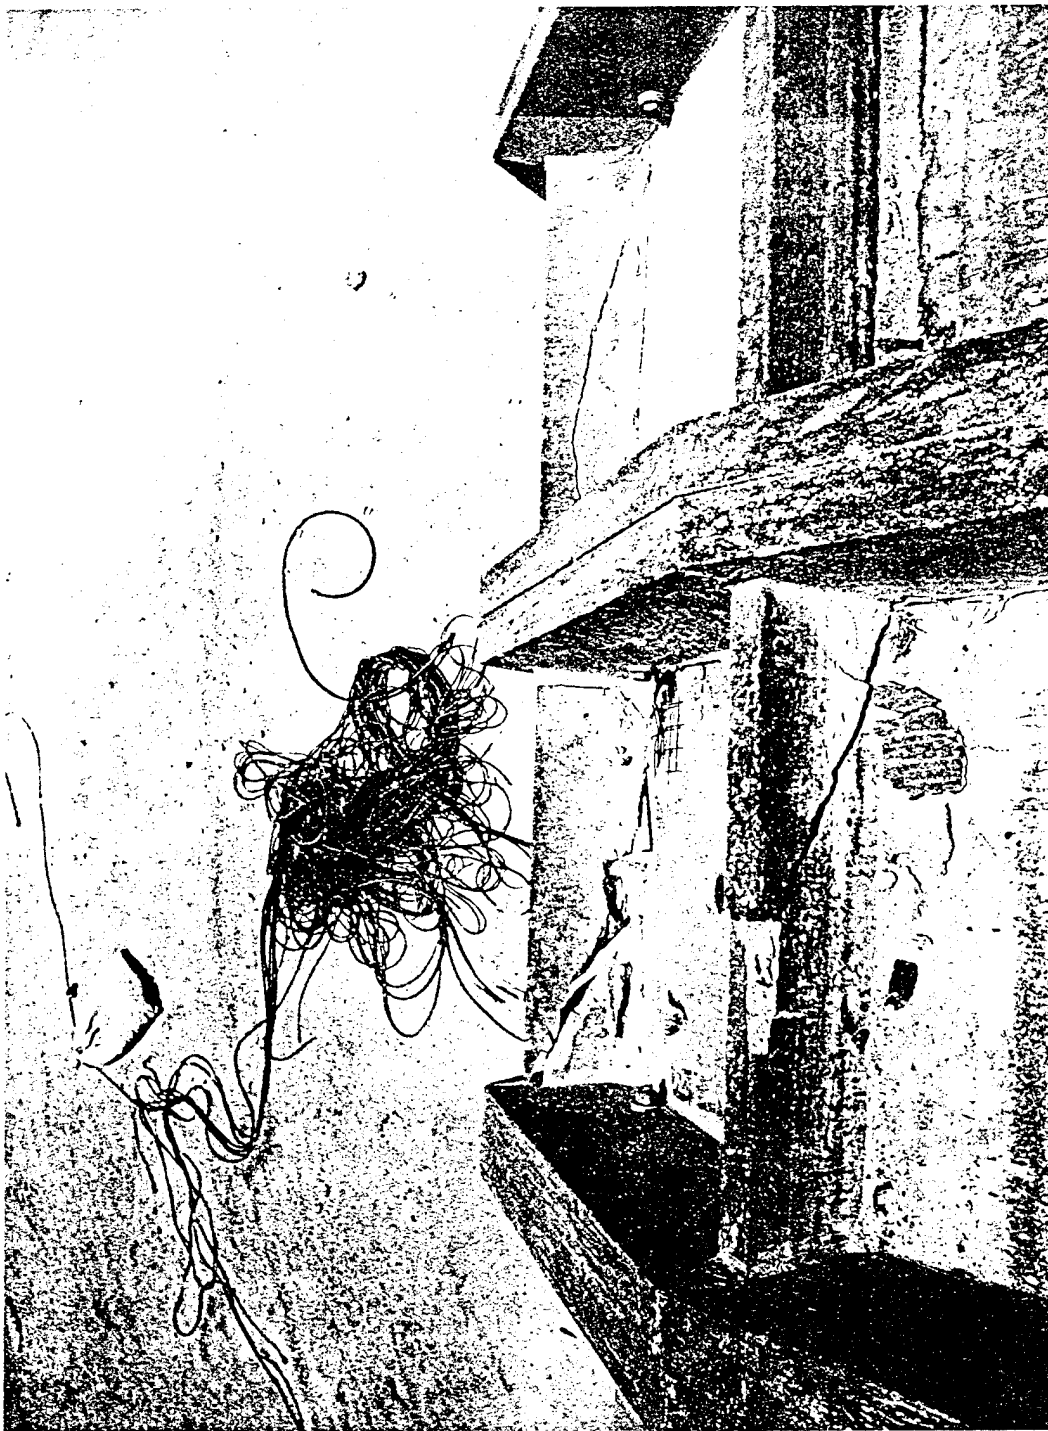
Fig. L. 386 Roof Section Toward Base of Ribs-out Panel Fourth from Right End of Structure, 3.2.4b

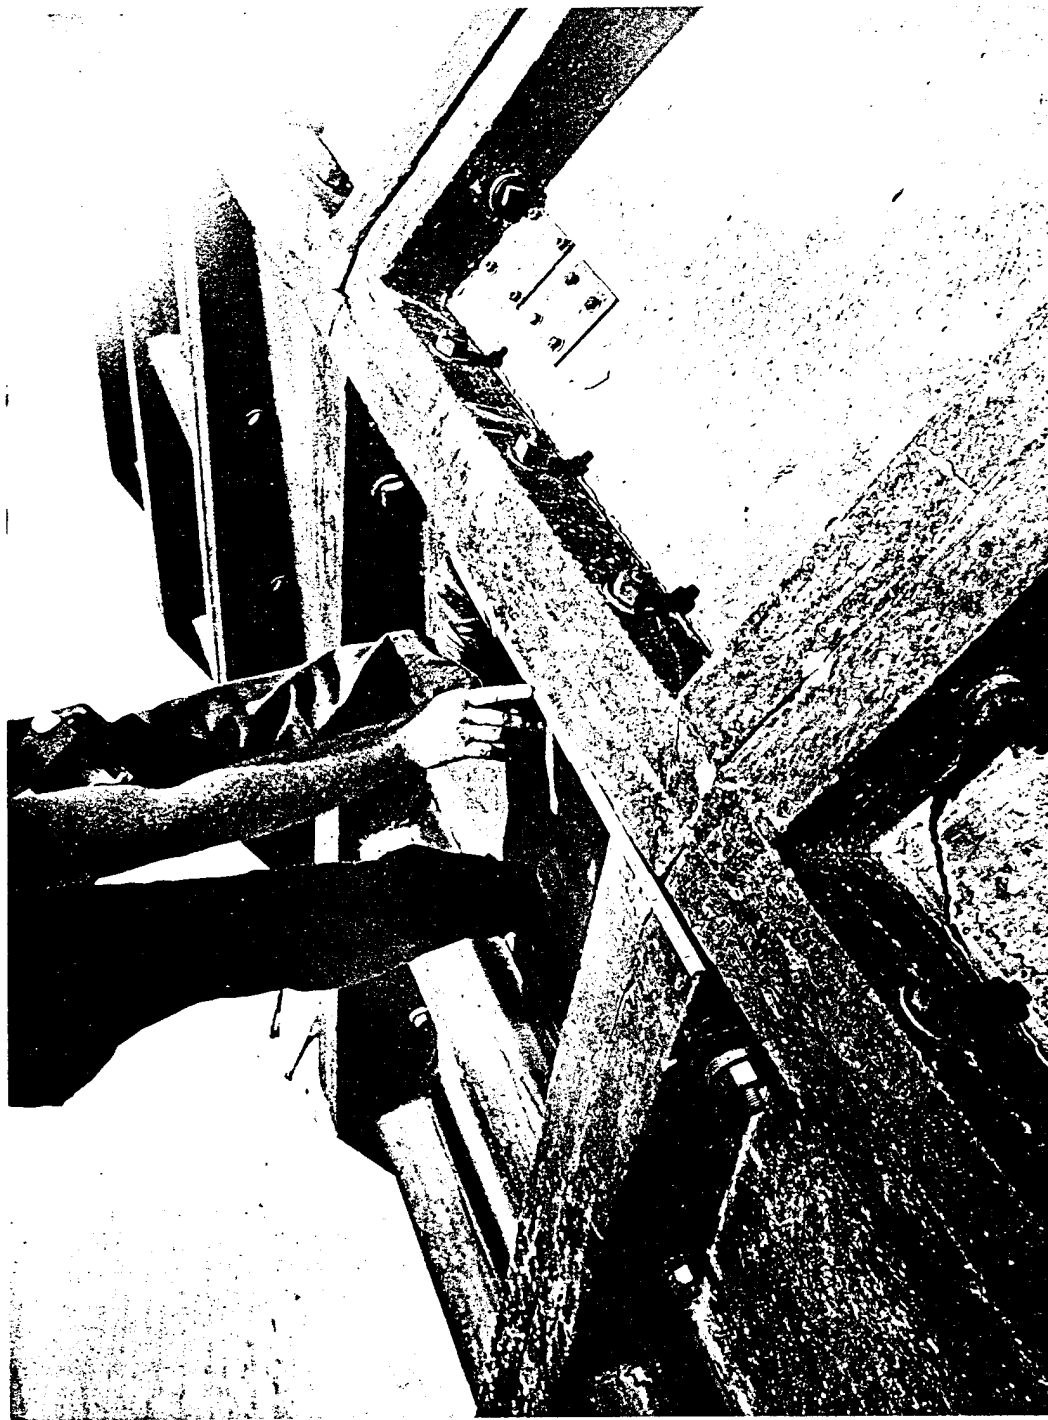
Fig. L. 387 Detail View of Joint of Ribs-out Panels Fourth and Fifth from Right End of Structure, 3.2.4b

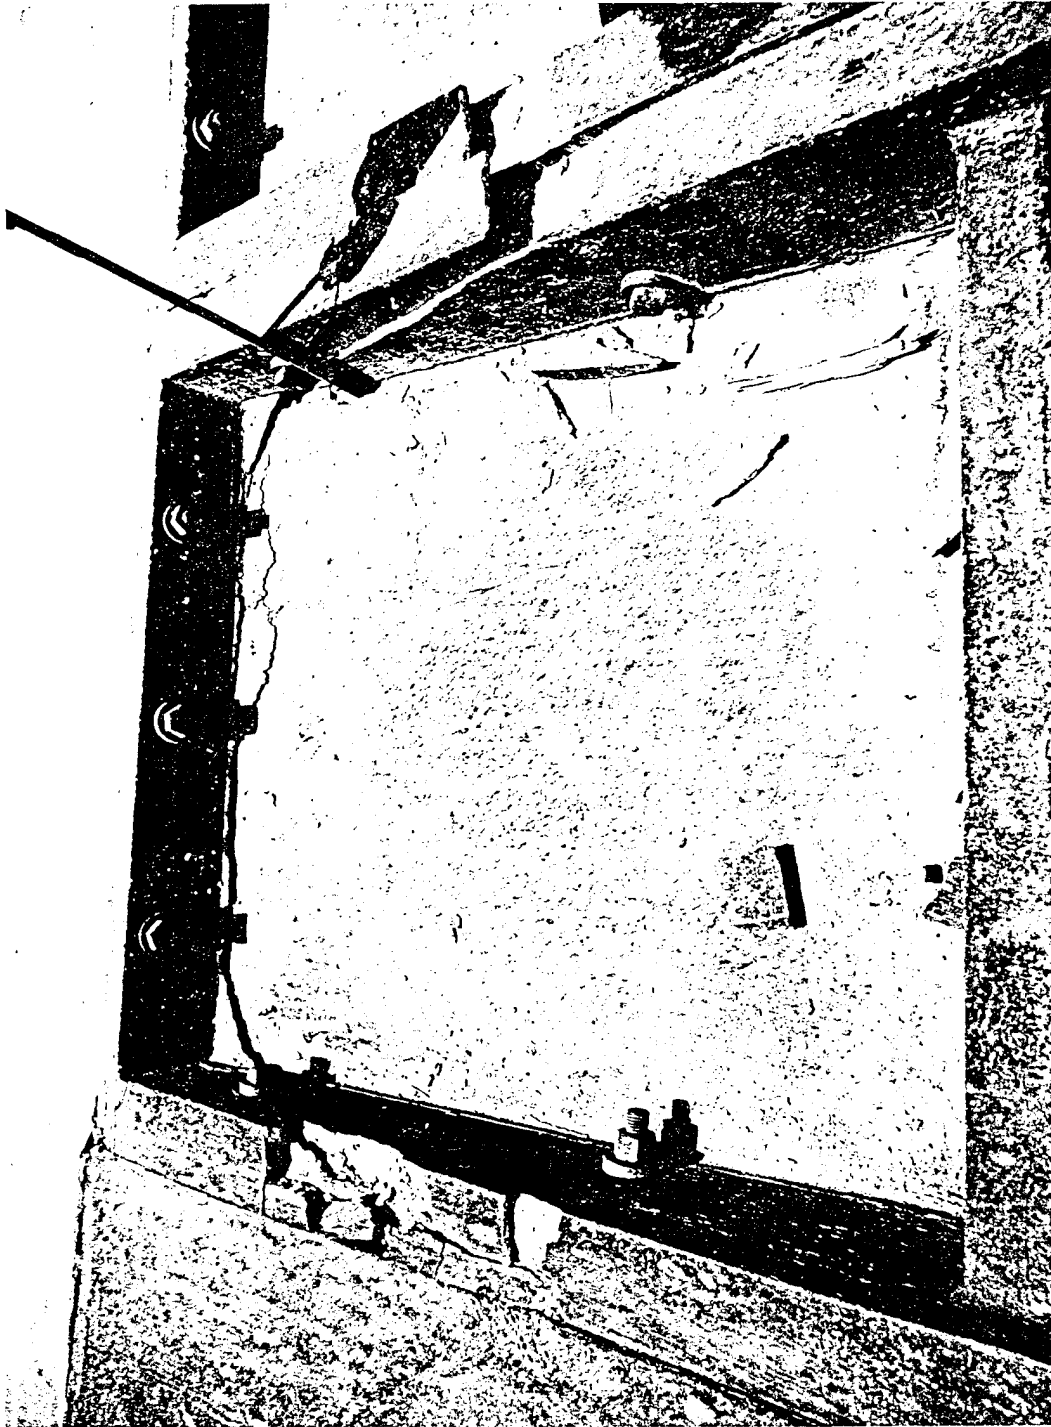
Fig. L. 388 Roof Section Toward Crown of Ribs-out Panel Fifth from Right End of Structure, 3. 2. 4b

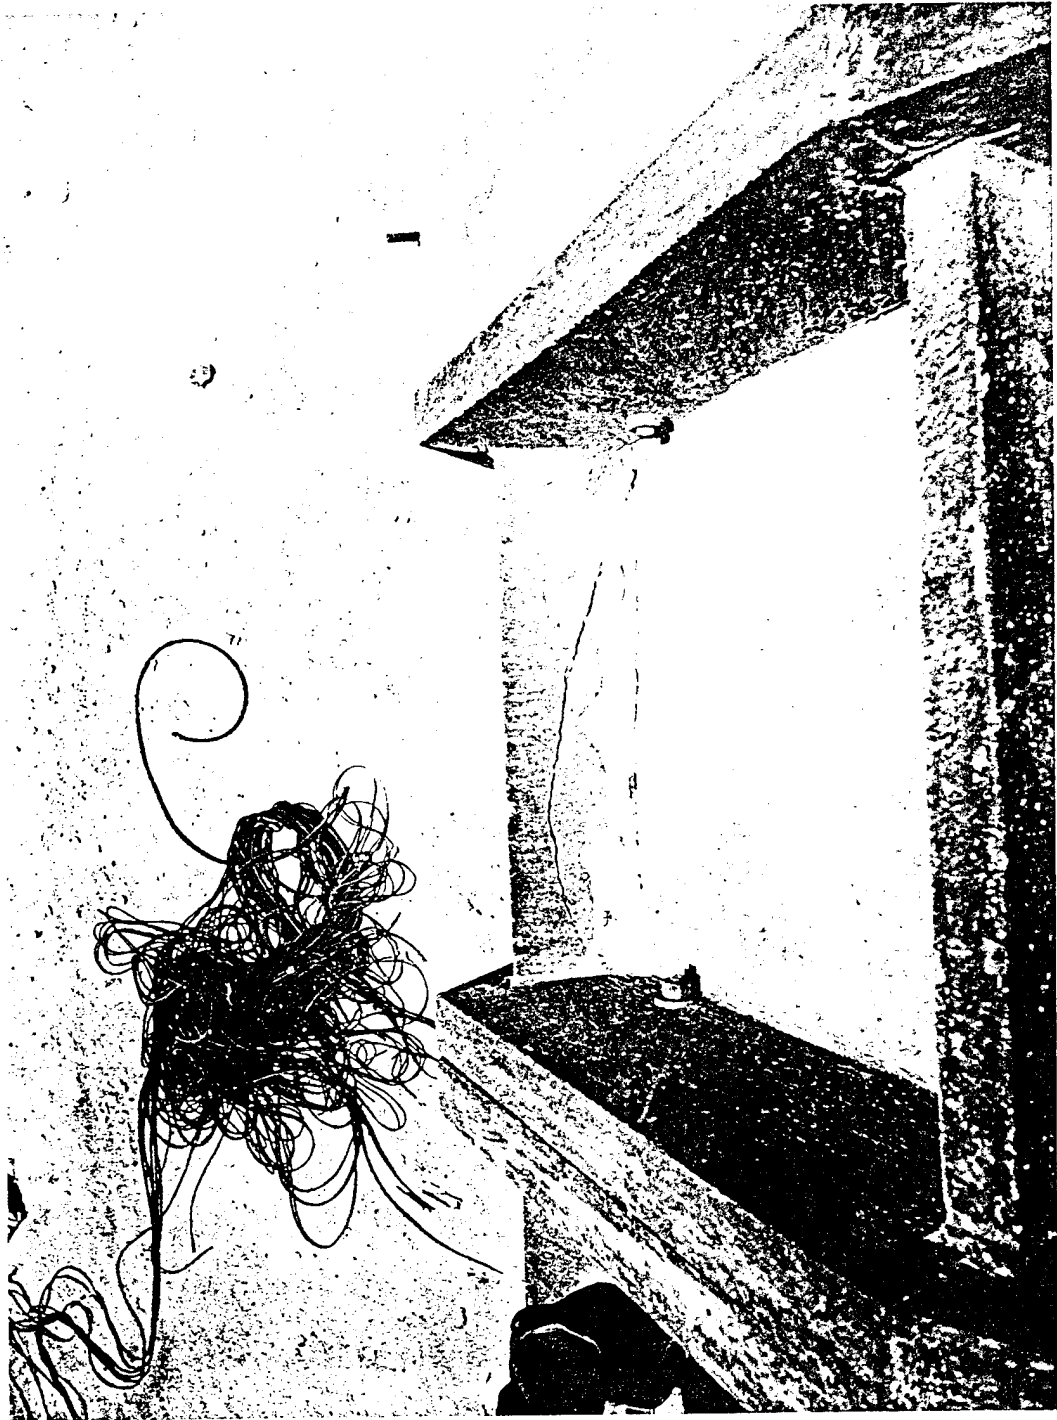
Fig. L. 389 Roof Section toward Base of Ribs-out Panel Fifth from Right End of Structure, 3.2.4b

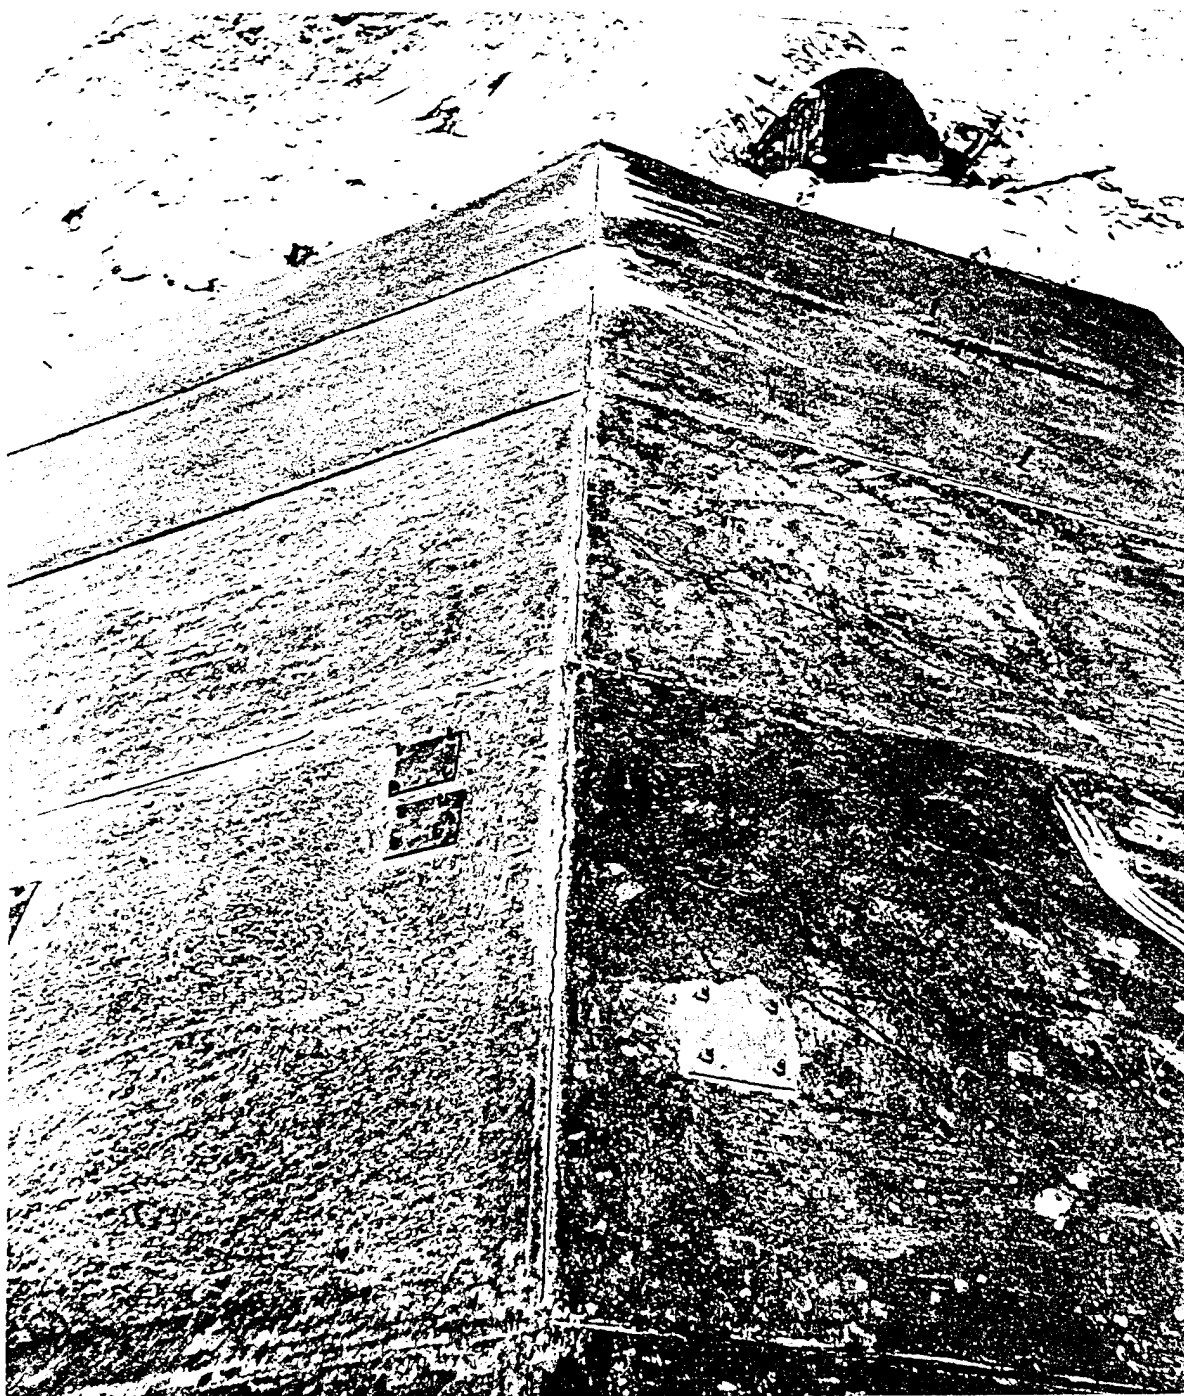
Fig. L.390 Detail of Crown Intersection of Ribs-in Panels, Structure 3.2.4b

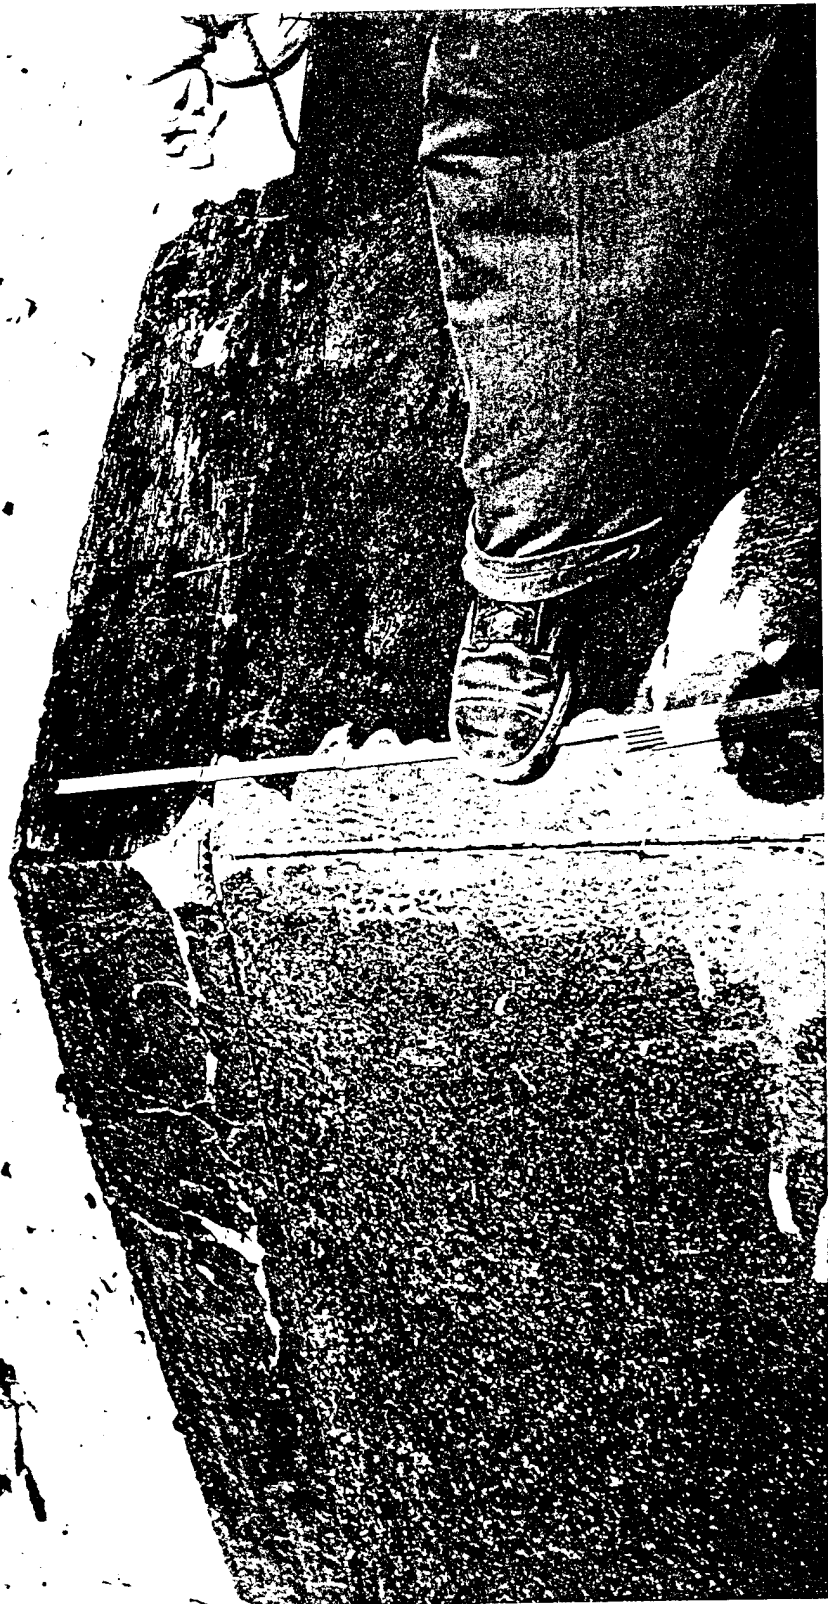
Fig. L. 391 Detail of Intersection of Left End Wall and Ribs-in Panels Adjacent to Left End, Structure 3.2.4b

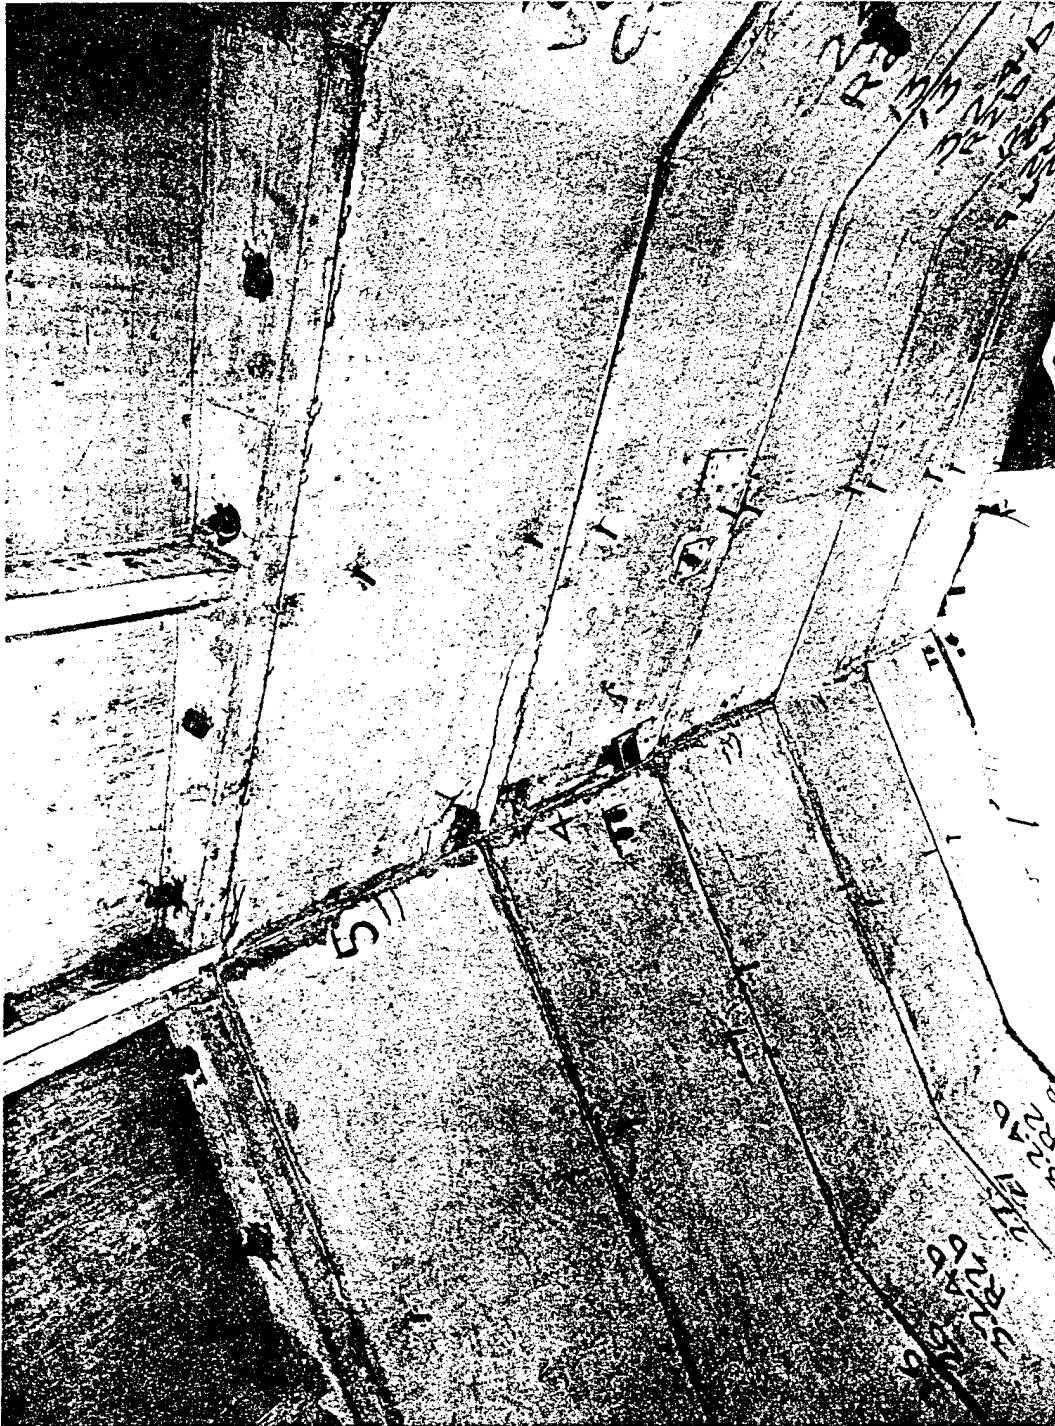
Fig. L. 392 Interior View of Roof Section of Ribs-out Panels, Structure 3.2.4b
